Evaluation Report

SED Model 912 Grain Loss Monitor

A Co-operative Program Between

SED MODEL 912 GRAIN LOSS MONITOR MANUFACTURED

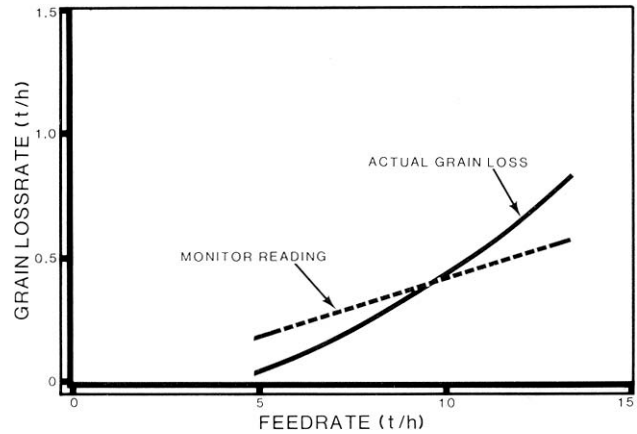
FIGURE 4 is a comparison of actual losses from a conventional combine to the losses as indicated by the SED 912 in a field of Bonanza barley. In addition to the simple calibration procedure the manufacturer also provides a procedure whereby the monitor can be calibrated to indicate the rate of grain loss in bushels per hour. This graph was prepared to illustrate the accuracy of the monitor in

FIGURE 4. Comparison of Monitor Reading to Actual Combine Lossrate in a Field of Bonanza Barley.

performing this. The position of the monitor curve in relation to the actual lossrate curve is determined by the calibration control. FIGURE 4 represents monitor settings for which the monitor curve most closely approximates the actual loss curve, and further adjustment cannot improve the overall accuracy.

From FIGURE 4 it can be seen, as is common with most loss monitors, that the monitor curve does not directly follow the actual loss curve and does not increase as rapidly as the actual loss curve at high feedrates. Therefore, if the monitor is used to measure combine loss in bushels per hour, significant error should be expected. However, when properly calibrated, the SED 912 can be effective in indicating changes in combine performance. The monitor effectively senses changes in the combine lossrate and a higher meter reading corresponds to higher losses. For example, in the crop shown in FIGURE 4, if the monitor is calibrated so that the meter midpoint reading corresponds to a feedrate of about 6 t/h, combine loss can be maintained at an acceptable level while operating the combine near peak efficiency if combine speed is adjusted to hold the meter at midpoint.
